INSPECTION REPORT

25 Client Street
San Clemente, CA 92673

September 22, 2016

Prepared by: Peter Hopkins
ICC Certified Inspector

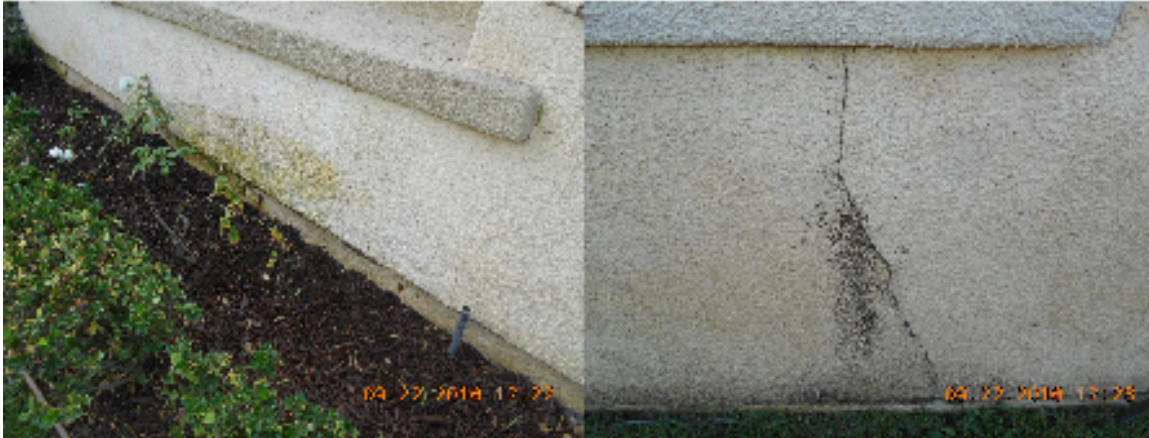
STUCCO:

There are moderate sized cracks in the stucco that should be patched and sealed as part of preparation for the next painting. Flexible patching materials are recommended rather than rigid cementitious patching compounds.

It appears sprinklers are overspraying stucco as evidenced by staining. We recommend to adjust sprinklers to not spray structure.

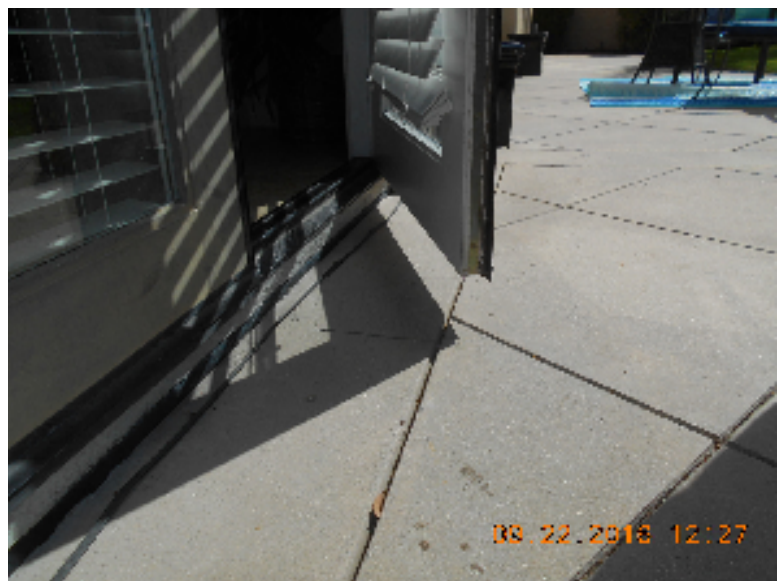
DOORS:

The exterior doors appear to be properly installed and in serviceable condition with exceptions noted. Some of the exterior doors open over a step which can be a trip hazard. We recommend caution when exiting or installation of a proper landing. Note: Current standards allow a maximum 1" from base of outswing door to landing.

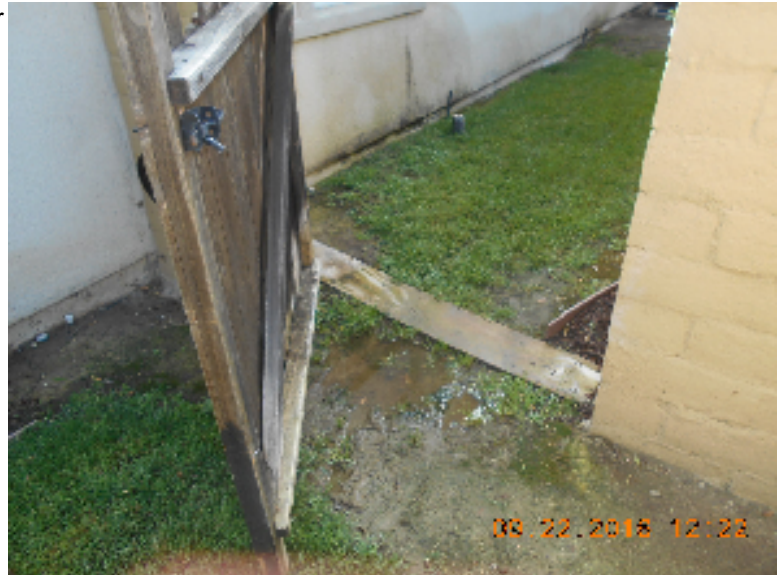
GRADING:

Grading is sloped toward the structure. Improper grading promotes water accumulation near the building and water penetration into structure, basements and crawl spaces. Regrading would help ensure that surface water flows away from the structure. An examination of the grounds revealed standing water in areas. This is indicative of poorly drained and/or moisture retentive soil. We recommend modifications as needed.

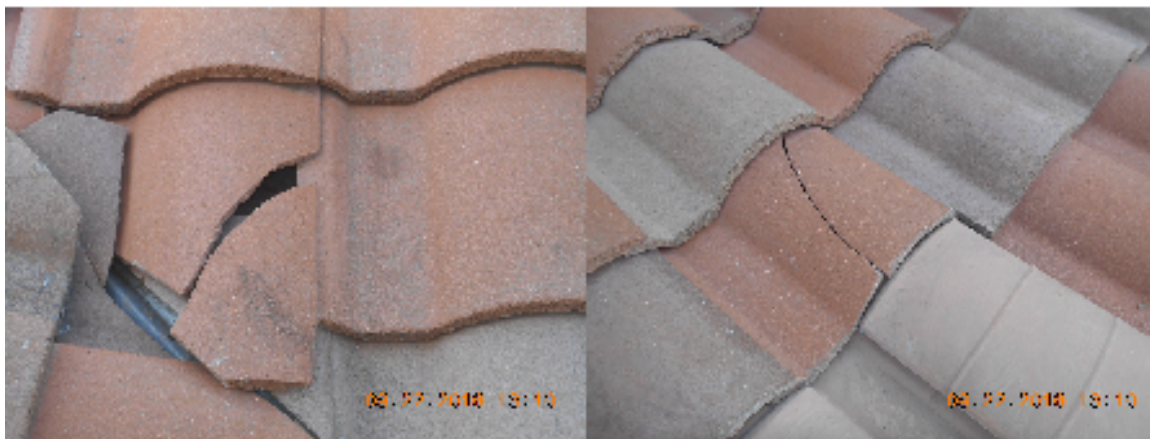
SURFACE:

The tile roof is in serviceable condition with minor exceptions. Attention to the items listed, together with routine maintenance, will keep it functional and maximize its expected useful life.

There are individual cracked, slipped or chipped tiles along the ridge and/or in the field. The number of affected tiles is small, but felt underlayment is exposed and we recommend repair to help prevent its deterioration.

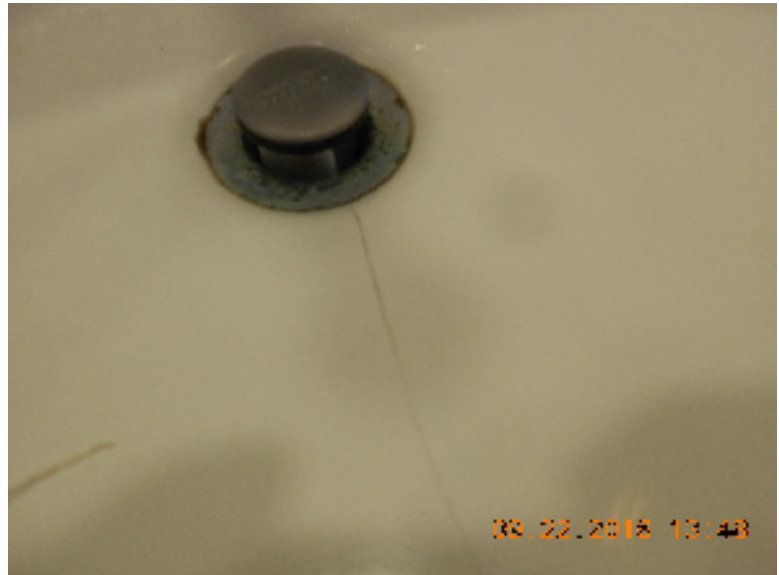
MASTER

The sink is cracked but was filled and did not leak, we recommend it be monitored and replaced as necessary.

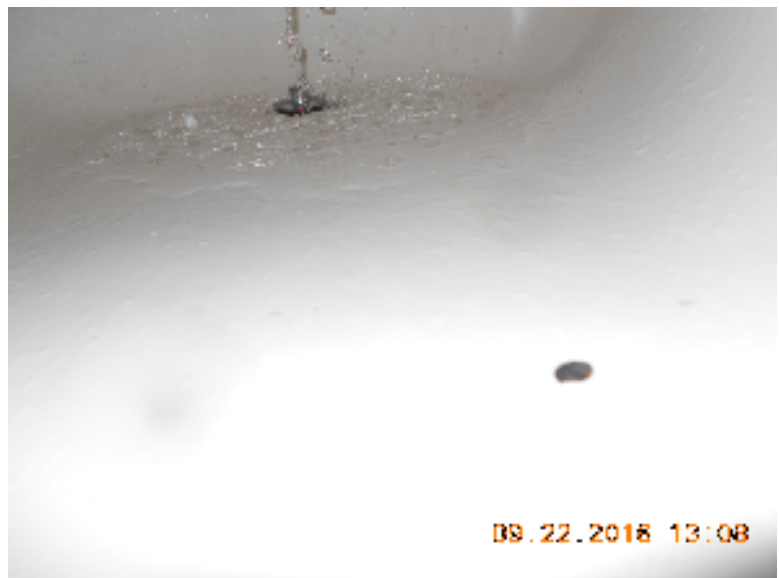
UPPER JACK/JILL

The surface finish of the bathtub is chipped/cracked. We recommend refinishing or replacement.

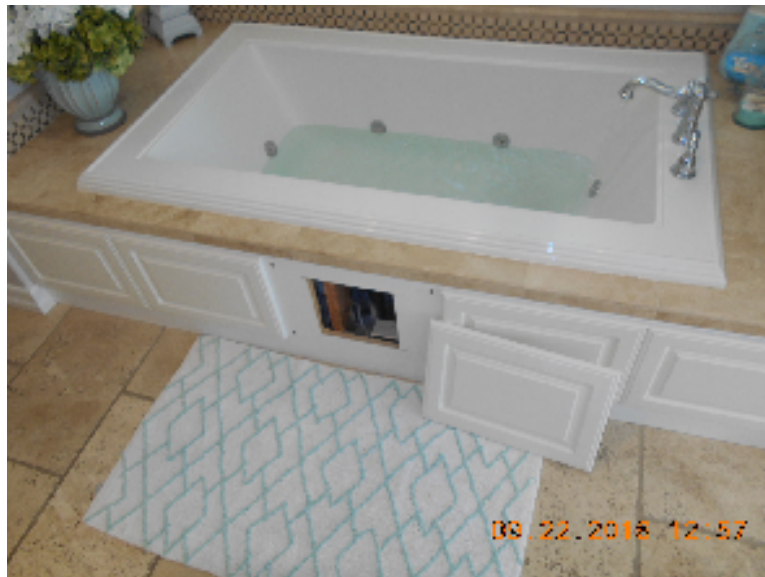
There was no proper equipment access or it was sealed to the pump motor. We recommend further review and installation as needed. Note: Center panel opened however motor is at end and not viewed.

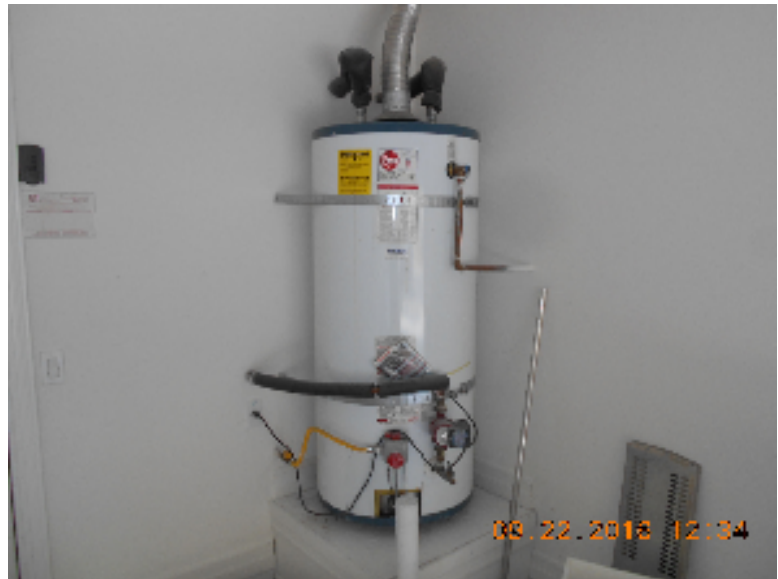
SEISMIC RESTRAINT:

Water heaters 75 gallon and above often require a 3rd strap as noted in the Health and Safety code or as directed by the State Architect. We recommend review with local jurisdiction and action as needed or verification that current strap is rated for 75 gallons.

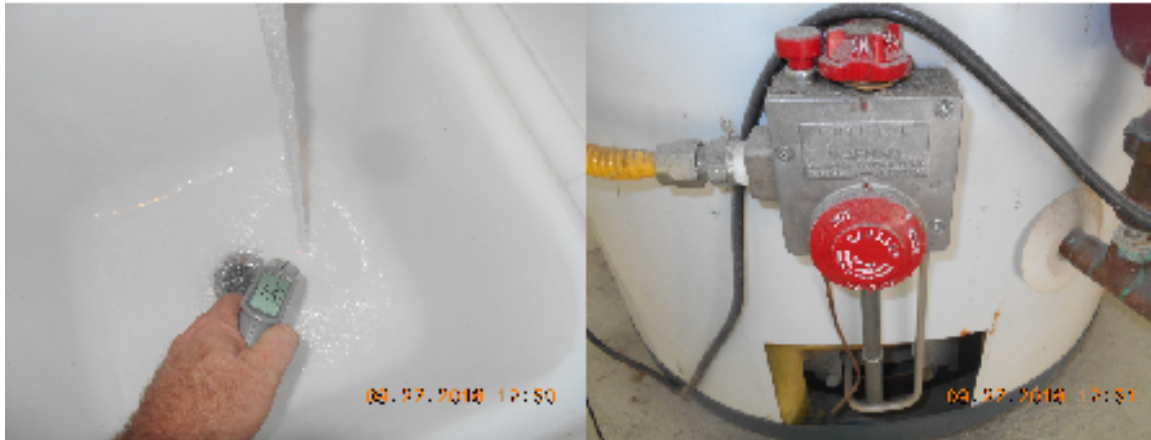
GENERAL COMMENT:

The temperature is set too high. Excessive temperature can be dangerous and inefficient. We recommend the temperature setting be lowered to provide safer, more efficient operation.

This water heater is beyond its expected service life. Although it is still operating, the need for replacement should be expected in the near future.

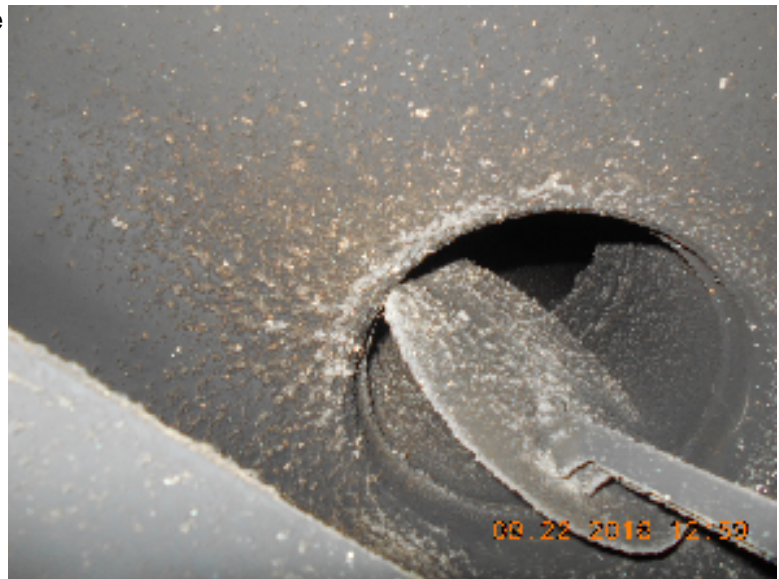
FIREPLACE(S):

Because of the build-up of soot and creosote we recommend the flue be cleaned to remove accumulated soot and creosote.

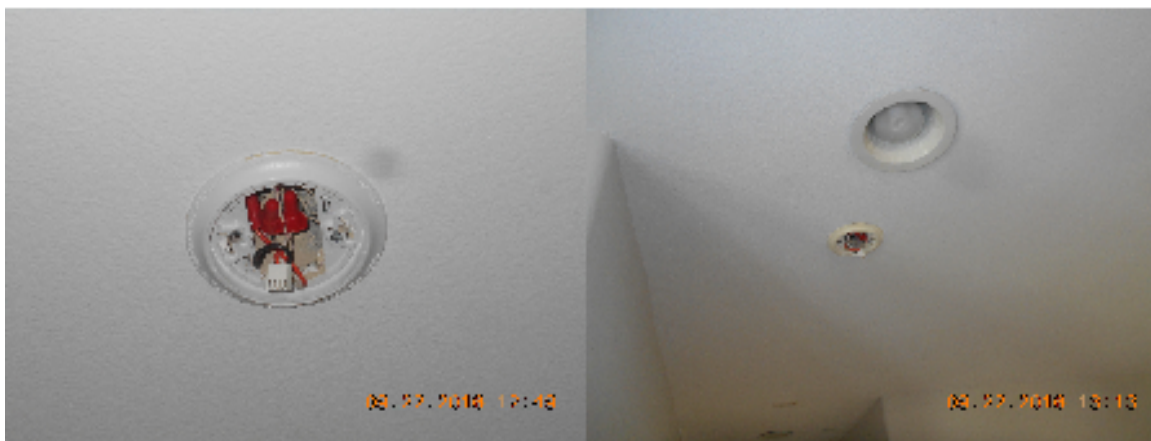
SMOKE DETECTOR(S):

One or more of the smoke detectors have been removed. We recommend installation of smoke detectors in compliance with today's standards.

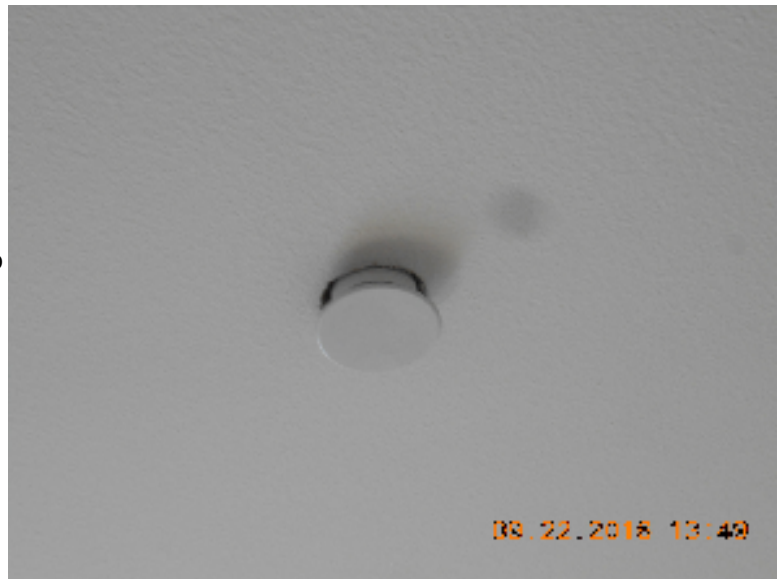
Some of the sprinkler heads/caps have come down slightly. We recommend to reset.

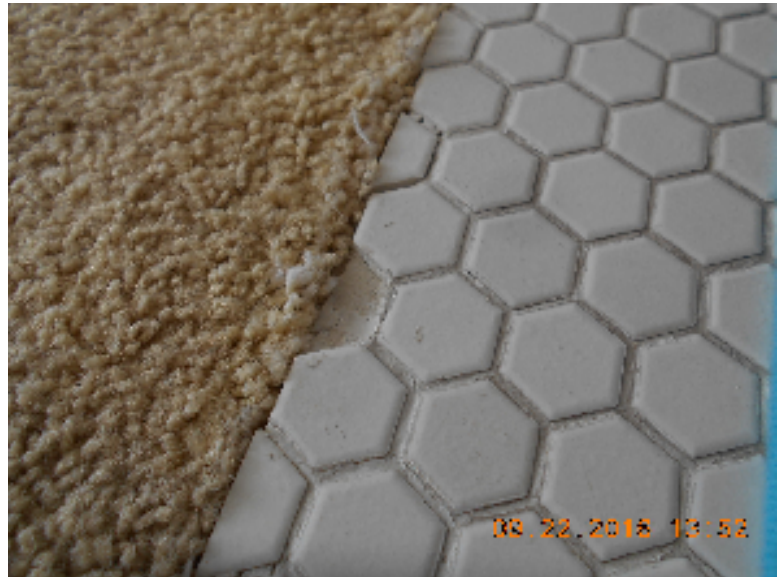
There are gaps noted between flooring and tub/shower. We recommend caulking floor to help prevent moisture entry.

The floor tile has cracks or missing pieces, we recommend repair as needed.

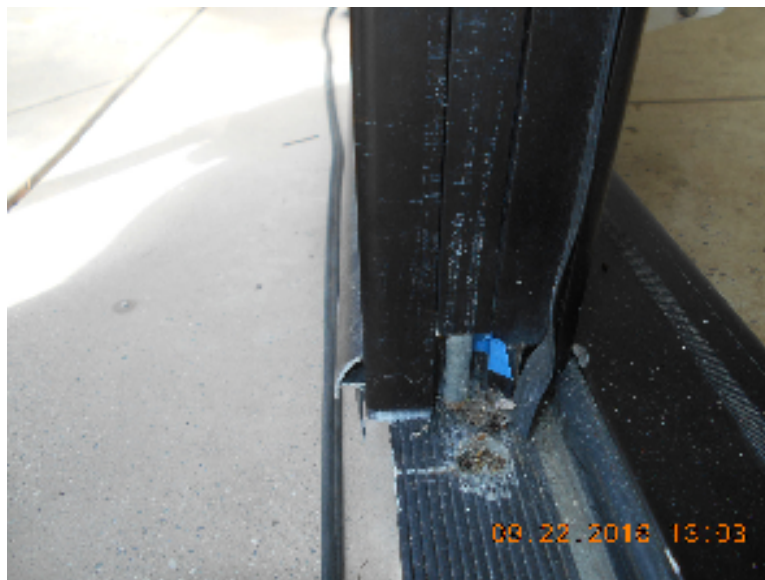
DOORS

The rear exterior door lower latch does not fully set due to door trim not allowing to fully close. We recommend adjustment as needed for proper operation.
